**Flood Control Project Maintenance
Levee Inspections**

Fall 2015 Levee Maintenance Deficiency Summary Report

Sacramento River Basin

Sutter Maintenance Yard Maintenance Area 0001

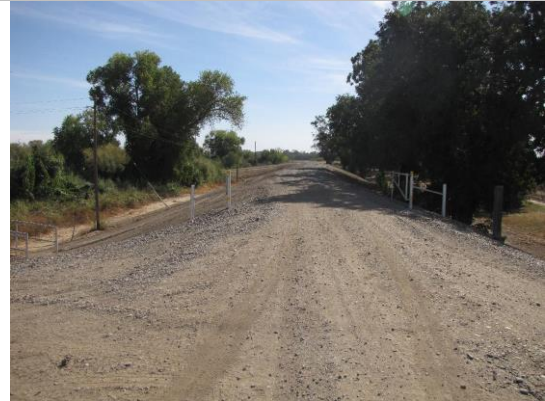
Photo 2 of 3 : UCIP_FA_2015_6297.jpg

Action/Comments					
Inspector Comments: FS_ID:44645 DS_ID:17570 EP_NO: 9482 FS_HLM: 7.142 Repair Type: Non-Urgent Crossing Status: Found UCIP Comments: 4/20/2015 Structure is operational. WS slide gate was unbrried aloowing water to irrigate the fields. It gets reburied during highwater season. Structure is buried and non-operational. This crossing was listed in the USACE Periodic Inspection as ID# USACE_CESPK_MA1C_2010_p_0288 for sluice gate closed and backfilled on WS and full of sediment with wingwall cracked on LS.7/18/2013 WS screw gate has been cleared of dirt and is open to irrigate LS fields. LS outlet is still mostly blocked by sediment.12/17/2013 WS screw gate was closed and buried by soil again6/23/2014 Same as last inspection. Soli dug out again and water flowing through crossing. FIELD_STRUCT_DESC: 2 of 2: 36-inch concrete pipes through the levee. Wooden slide gates on waterward end. Concrete culvert through levee. Sliding metal gate noted in O&M manual. This entry could match the Drainage or Irrigation Structure referenced in the O&M manual (Station 370+90) (USACE-1955). (ABO No. 9482-1974, Elizabeth M. Farnsworth) FS Date: 04/22/2015

Overview of levee crown looking downstream at crossing.

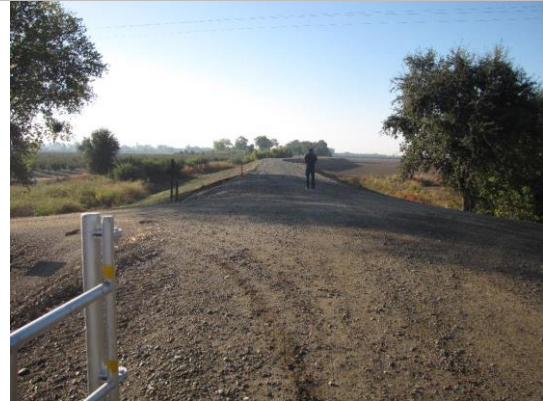
Photo 1 of 2 : UCIP_FA_2015_6299.jpg

Inspector Comments: FS_ID:44646
 DS_ID:16456
 EP_NO: N/A
 FS_HLM: 7.421
 Repair Type: Non-Urgent
 Crossing Status: Found
 UCIP Comments: 4/20/2015 Same as last inspection. Rebar pin was still in place holding the gate opened. Sediment and debris on waterward and landward side. This crossing was listed in the USACE Periodic Inspection as ID# USACE_CESPK_MA1C_2010_p_0293 for wooden slide gate held open by a piece of rebar acting as a pin. 7/18/2013 Same as last inspection. 12/17/2013 Same as last inspection. 6/23/2014 Same as last inspection.
 FIELD_STRUCT_DESC: 5 foot by 6 foot concrete box culvert through the levee and access ramp. Two wooden slide gates on waterward end. Concrete v-ditch along landward toe. This entry matches the Drainage and Irrigation Structure referenced in O&M manual (Station 385+33.5).
 FS Date: 04/22/2015

Overview of levee crown looking downstream at crossing.

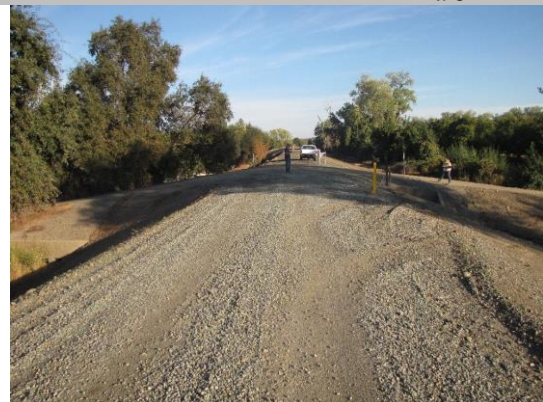
Photo 2 of 2 : UCIP_FA_2015_6348.jpg

Overview of levee crown looking upstream at crossing.

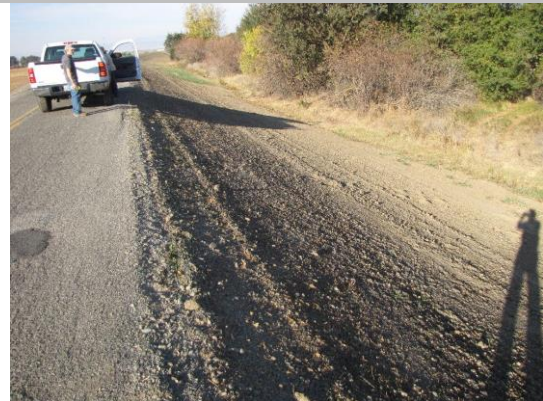
Photo 1 of 3 : UCIP_FA_2015_6349.jpg

LM Start	7.58	Rating **	M	Issue No.	661
LM End	7.58	Issue Type +	En	Location *	WS
Category	Supplemental			GPS Latitude/Longitude	
				Start	End
Item	DWR UCIP Field Study			39.297384 °	39.297384 °
				-122.022989 °	-122.022989 °
DWR ID					
Action/Comments					
Inspector Comments: FS_ID:44647 DS_ID:16455 EP_NO: 12334 FS_HLM: 7.743 Repair Type: Non-Urgent Crossing Status: Found UCIP Comments: 4/20/2015 Same as last inspection.Siphon breaker housing unit is bent and has debris inside. LS outlet not found.7/18/2013 Same as last inspection.12/17/2013 Same as last inspection.6/23/2014 Same as last inspection. FIELD_STRUCT_DESC: 10-inch steel pipe through levee, 3 feet below the crown. Centrifugal pump on the bank. Siphon breaker on landward shoulder of the levee. (Permit No. 12334-1978, James Jean) FS Date: 04/22/2015

View of waterward side-no features on levee shoulder or slope.

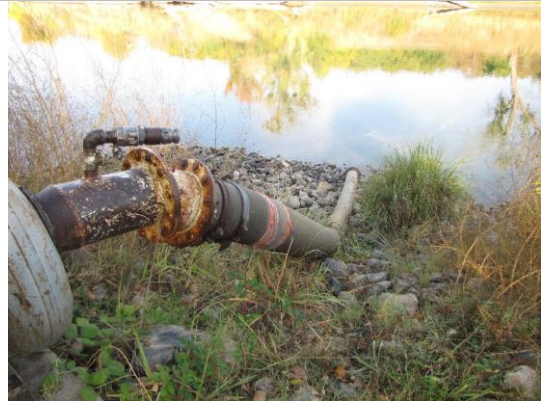
Photo 2 of 3 : UCIP_FA_2015_6350.jpg

Inspector Comments: FS_ID:44647
DS_ID:16455
EP_NO: 12334
FS_HLM: 7.743
Repair Type: Non-Urgent
Crossing Status: Found
UCIP Comments: 4/20/2015 Same as last inspection. Siphon breaker housing unit is bent and has debris inside. LS outlet not found. 7/18/2013 Same as last inspection. 12/17/2013 Same as last inspection. 6/23/2014 Same as last inspection.
FIELD_STRUCT_DESC: 10-inch steel pipe through levee, 3 feet below the crown. Centrifugal pump on the bank. Siphon breaker on landward shoulder of the levee. (Permit No. 12334-1978, James Jean)
FS Date: 04/22/2015

Pump located on waterward bank.

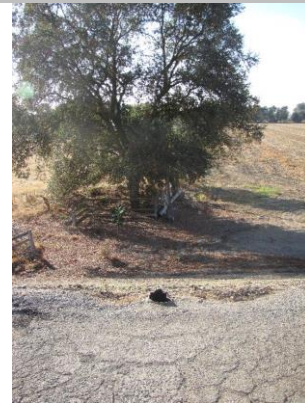
Photo 3 of 3 : UCIP_FA_2015_6351.jpg

View of landward side with appurtances present on levee shoulder.

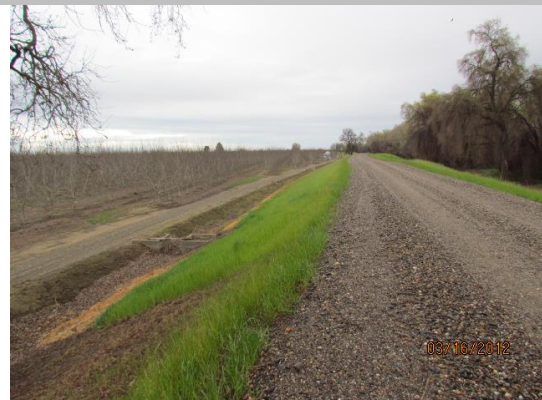
Photo 1 of 1 : FA_2015_MA0001_297_25_20150910_00010.jpg

LM Start	8.73	Rating **	M	Issue No.	25
LM End	9.19	Issue Type +	En	Location *	LS
Category	Earthen Levee			GPS Latitude/Longitude	
				Start	End
Item	Encroachments			39.308390 °	39.315125 °
				-122.031157 °	-122.030206 °
DWR ID	DWR_MA0001_01_s_2012_25				
Action/Comments					
Ditch

View of the ag. ditch along the L/S toe.

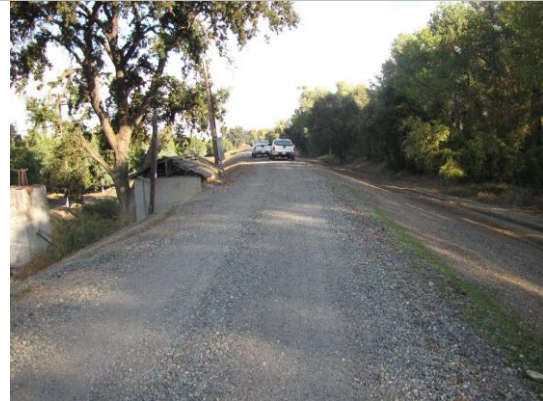
Photo 1 of 3 : UCIP_FA_2015_6487.jpg

Inspector Comments: FS_ID:44648
 DS_ID:16454
 EP_NO: 9466
 FS_HLM: 9.11
 Repair Type: Non-Urgent
 Crossing Status: Found
 UCIP Comments: 4/20/2015 Same as last inspection.No access to inspect slide gate on LS. Roof of pumping house deteriorating and debris scattered on landward side. WS crossing not found. This crossing was listed in the USACE Periodic Inspection as ID# USACE_CESPK_MA1C_2010_p_345 no issues recorded.7/18/2013 Same as last inspection.12/17/2013 Same as last inspection.6/23/2014 Same as last inspection.
 FIELD_STRUCT_DESC: 24-inch steel pipe through the levee. Slide gate in concrete riser on the landward slope. Pump house encroaches into the landward slope. Two service poles on the landward shoulder. (ABO No. 9466-1974, Roman Catholic Bishop of Sacramento)
 FS Date: 04/22/2015

Overview of levee crown looking upstream at crossing.

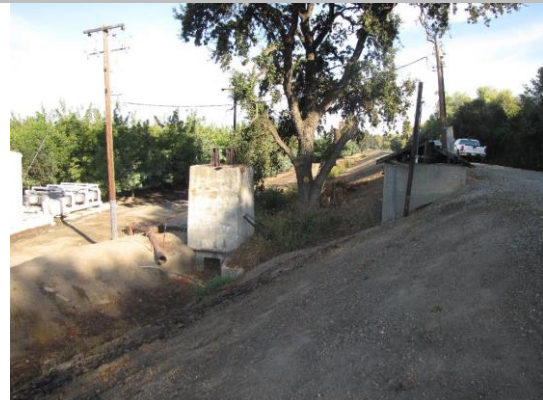
Photo 2 of 3 : UCIP_FA_2015_6488.jpg

View of pump and standpipe located on landward side.

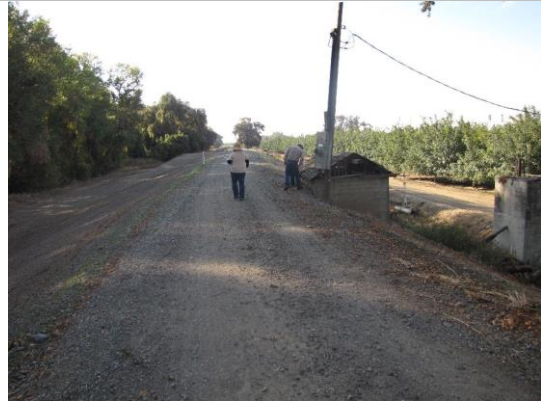
Photo 3 of 3 : UCIP_FA_2015_6489.jpg

Overview of levee crown looking downstream at crossing.

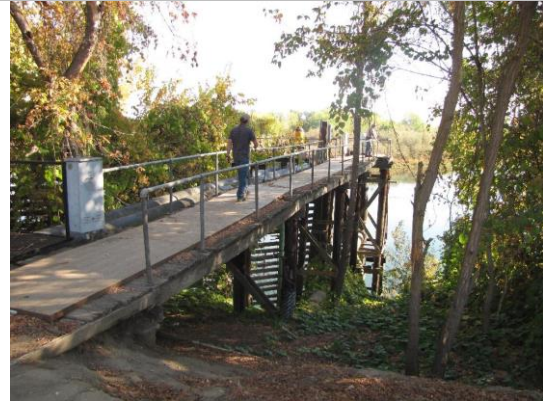
Photo 1 of 2 : UCIP_FA_2015_6520.jpg

Inspector Comments: FS_ID:44651
 DS_ID:16453
 EP_NO: N/A
 FS_HLM: 10.43
 Repair Type: Urgent
 Crossing Status: Found
 UCIP Comments: 4/20/2015 Erosion happening near WS shoulder where the pipes enter the levee. May just be caused by rain runoff. Landward side has been completely altered. Need to find permit for new work. 7/18/2013 Same as last inspection. 12/17/2013 Same as last inspection. 6/23/2014 Same as last inspection.
 FIELD_STRUCT_DESC: 24-inch steel pipe through levee. Gate valve on the waterward end. (USACE, 1955) This entry matches the Drainage and Irrigation Structure referenced in O&M manual (538+42).
 FS Date: 04/22/2015

Dual 14-inch pipes along catwalk. 24-inch pipe crosses approximately 8 feet below catwalk floor.

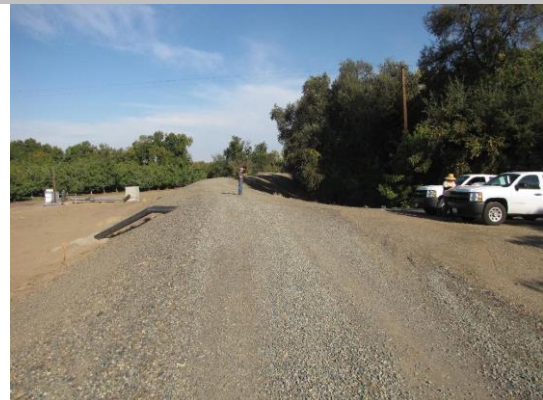
Photo 2 of 2 : UCIP_FA_2015_6521.jpg

Overview of levee crown looking upstream at multiple crossings.

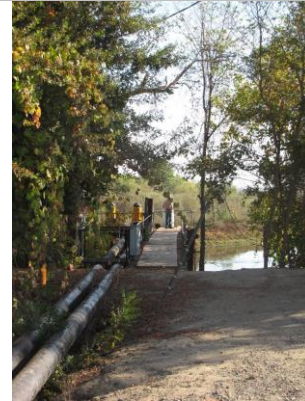
Photo 1 of 3 : UCIP_FA_2015_6493.jpg

View of catwalk and pump station located on waterward side.

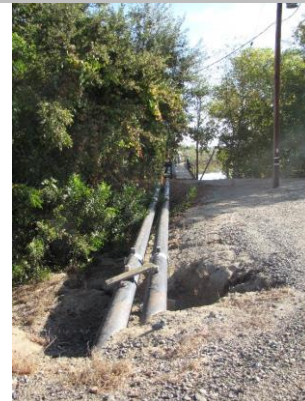
Photo 2 of 3 : UCIP_FA_2015_6494.jpg

View of waterward side looking at crossing.

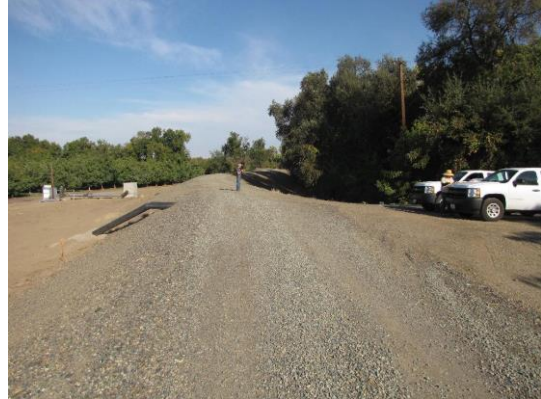
Photo 3 of 3 : UCIP_FA_2015_6495.jpg

Overview of levee crown looking upstream at crossing.

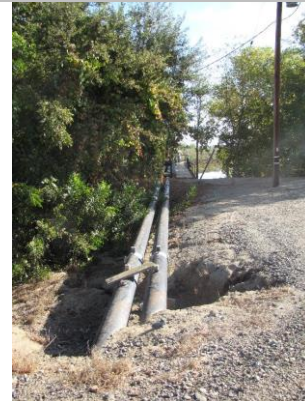
Photo 1 of 3 : UCIP_FA_2015_6496.jpg

LM Start	10.21	Rating **	U	Issue No.	667
LM End	10.21	Issue Type +	En	Location *	WS
Category	Supplemental			GPS Latitude/Longitude	
				Start	End
Item	DWR UCIP Field Study			39.329750 °	39.329750 °
				-122.029602 °	-122.029602 °
DWR ID					
Action/Comments					
Inspector Comments: FS_ID:44652 DS_ID:16452 EP_NO: 1800 FS_HLM: 10.43 Repair Type: Urgent Crossing Status: Found UCIP Comments: 4/20/2015 Erosion happening near WS shoulder where the pipes enter the levee. May just be caused by rain runoff.This crossing has been completely modified--need recent permit issued to allow work on levee and levee toe. Was levee compacted to CVFPB standards? This crossing was listed in the USACE Periodic Inspection as ID# USACE_CESPK_MA1C_2010_p_0371 unable to determine why this crossing was assigned "U".7/18/2013 Same as last inspection.12/17/2013 Same as last inspection.6/23/2014 Same as last inspection. FIELD_STRUCT_DESC: 1 of 2: 14-inch steel pipes through levee. Siphon breakers on the waterward end. (Permit No. 1800-1959, Jimeno Rancho) FS Date: 04/22/2015

View of 2-14 inch crossings through levee on waterward side.

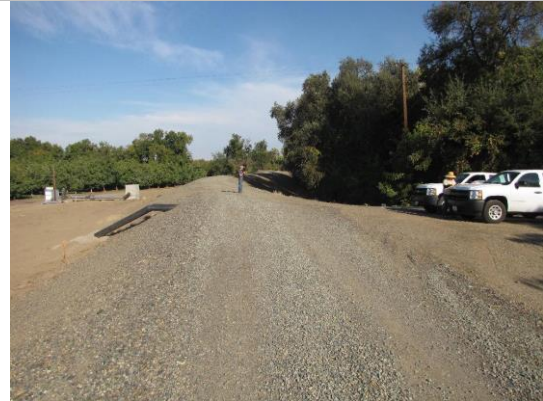
Photo 2 of 3 : UCIP_FA_2015_6497.jpg

Action/Comments					
Inspector Comments: FS_ID:44652 DS_ID:16452 EP_NO: 1800 FS_HLM: 10.43 Repair Type: Urgent Crossing Status: Found UCIP Comments: 4/20/2015 Erosion happening near WS shoulder where the pipes enter the levee. May just be caused by rain runoff. This crossing has been completely modified--need recent permit issued to allow work on levee and levee toe. Was levee compacted to CVFPB standards? This crossing was listed in the USACE Periodic Inspection as ID# USACE_CESPK_MA1C_2010_p_0371 unable to determine why this crossing was assigned "U". 7/18/2013 Same as last inspection. 12/17/2013 Same as last inspection. 6/23/2014 Same as last inspection. FIELD_STRUCT_DESC: 1 of 2: 14-inch steel pipes through levee. Siphon breakers on the waterward end. (Permit No. 1800-1959, Jimeno Rancho) FS Date: 04/22/2015

Overview of levee crown looking upstream at crossing.

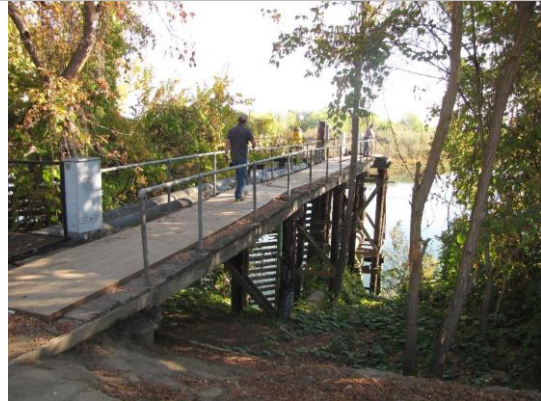
Photo 3 of 3 : UCIP_FA_2015_6519.jpg

Inspector Comments: FS_ID:44652
 DS_ID:16452
 EP_NO: 1800
 FS_HLM: 10.43
 Repair Type: Urgent
 Crossing Status: Found
 UCIP Comments: 4/20/2015 Erosion happening near WS shoulder where the pipes enter the levee. May just be caused by rain runoff. This crossing has been completely modified--need recent permit issued to allow work on levee and levee toe. Was levee compacted to CVFPB standards? This crossing was listed in the USACE Periodic Inspection as ID#
 USACE_CESPK_MA1C_2010_p_0371 unable to determine why this crossing was assigned "U". 7/18/2013 Same as last inspection. 12/17/2013 Same as last inspection. 6/23/2014 Same as last inspection.
 FIELD_STRUCT_DESC: 1 of 2: 14-inch steel pipes through levee. Siphon breakers on the waterward end. (Permit No. 1800-1959, Jimeno Rancho)
 FS Date: 04/22/2015

Catwalk, control panel, and pump station located on waterward side.

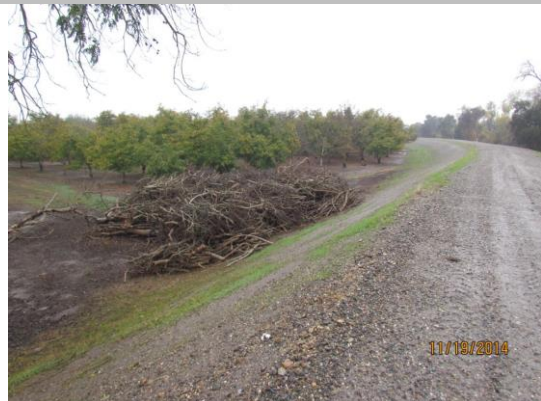
Photo 1 of 1 : FA_2015_MA0001_297_636_20150910_00021.jpg

LM Start	10.32	Rating **	M	Issue No.	636
LM End	10.32	Issue Type +	En	Location *	LS
Category	Earthen Levee		GPS Latitude/Longitude		
			Start	End	
Item	Encroachments		39.331320 °	39.331320 °	
			-122.029932 °	-122.029932 °	
DWR ID	DWR_MA0001_01_f_2014_636

View of the pruning along the landside toe.

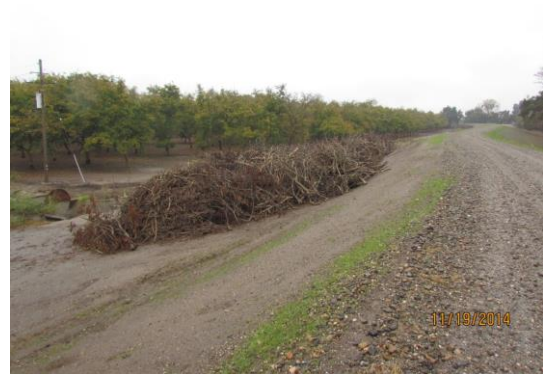
Photo 1 of 1 : FA_2015_MA0001_297_637_20150910_00022.jpg

LM Start	10.78	Rating **	M	Issue No.	637
LM End	10.78	Issue Type +	En	Location *	LS
Category	Earthen Levee			GPS Latitude/Longitude	
				Start	End
Item	Encroachments			39.337523 °	39.337523 °
				-122.032437 °	-122.032437 °
DWR ID	DWR_MA0001_01_f_2014_637				
Action/Comments					
Prunings

View of the pruning along the landside toe.

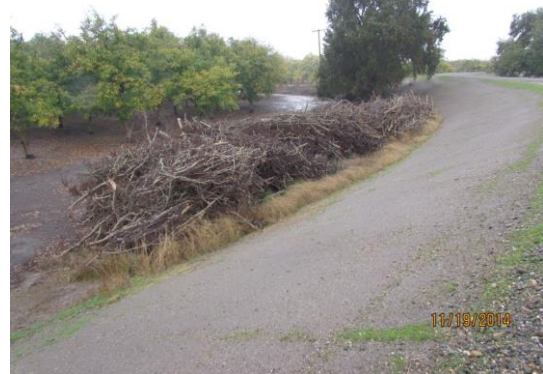
Photo 1 of 1 : FA_2015_MA0001_297_638_20150910_00023.jpg

LM Start	10.96	Rating **	M	Issue No.	638
LM End	10.96	Issue Type +	En	Location *	LS
Category	Earthen Levee			GPS Latitude/Longitude	
				Start	End
Item	Encroachments			39.340217 °	39.340217 °
				-122.032605 °	-122.032605 °
DWR ID	DWR_MA0001_01_f_2014_638				
Action/Comments					
Prunings

View of the pruning along the landside toe.

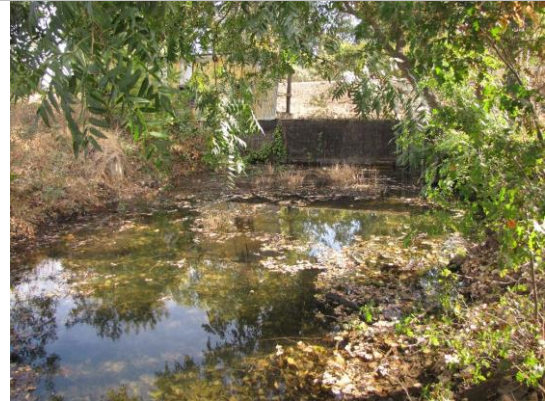
Photo 1 of 3 : UCIP_FA_2015_6618.jpg

LM Start	11.01	Rating **	M	Issue No.	668
LM End	11.01	Issue Type +	En	Location *	LS
Category	Supplemental			GPS Latitude/Longitude	
				Start	End
Item	DWR UCIP Field Study			39.340867 °	39.340867 °
				-122.032932 °	-122.032932 °
DWR ID

Drain channel inside ring levee.

Action/Comments					
Inspector Comments: FS_ID:46049					
DS_ID:16449					
EP_NO: 187					
FS_HLM: 11.253					
Repair Type: Non-Urgent					
Crossing Status: Found					
UCIP Comments: 4/21/2015 Same as last inspection. Need to determine if structure is still in use--contact owner. If abandoned structure--structure needs to be properly abandoned. This crossing was listed in the USACE Periodic Inspections as ID#					
USACE_CESPK_MA1C_2010_p_0393 missing gate. 7/18/2013					
Same as last inspection. 12/17/2013 Same as last inspection. 6/23/2014 Same as last inspection.					
FIELD_STRUCT_DESC: 1 of 2: 52-inch CMP through levee. Slide gate on waterward side and flap gate on landward side. Concrete headwalls at both sides. This structure is associated with another abandoned structure located on waterward side. Abandoned structure includes pump house, multiple concrete walls, and 3 additional crossings (2-30 inch pipes and 1-48 inch pipe). (Permit No. 187-1921, Compton-Delevan Irrigation District-Maxwell I.D.) New pump and platform installed and old pump house removed under Permit No. 9183-1973.

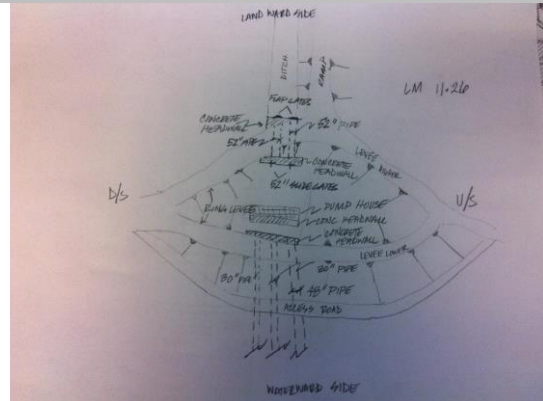
Photo 3 of 3 : UCIP_FA_2015_6620.jpg

Sketch of structure located at levee mile 11.26.

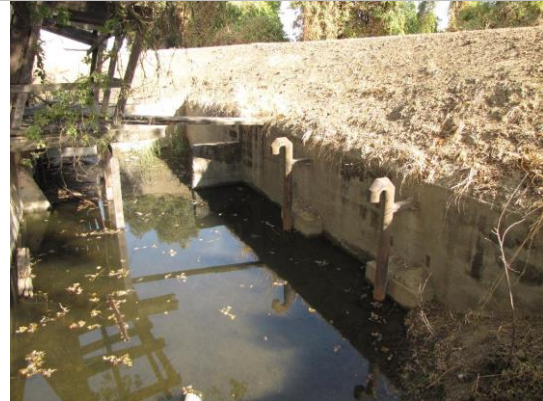
Photo 2 of 3 : UCIP_FA_2015_6622.jpg

Inspector Comments: FS_ID:46048
 DS_ID:17572
 EP_NO: 187
 FS_HLM: 11.26
 Repair Type: Urgent
 Crossing Status: Found
 UCIP Comments: 4/21/2015 Same as last inspection. Missing positive closure device. Need to determine if structure is still in use--contact owner. If abandoned structure--structure needs to be abandoned. This crossing was listed in the USACE Periodic Inspections as ID# USACE_CESPK_MA1C_2010_p_0393 missing gate. 7/18/2013 Same as last inspection. 12/17/2013 Same as last inspection. 6/23/2014 Same as last inspection.
 FIELD_STRUCT_DESC: 2 of 2: 52-inch CMP through levee. Slide gate on waterward side and flap gate on landward side. Concrete headwalls at both sides. This structure is associated with another abandoned structure located on waterward side. Abandoned structure includes pump house, multiple concrete walls, and 3 additional crossings (2-30 inch pipes and 1-48 inch pipe). (Permit No. 187-1921, Compton-Delevan Irrigation District-Maxwell I.D.) New pump and platform installed and old pump house removed under Permit No. 9183-1973.

Concrete headwall with multiple crossings (2-30 inch pipes and 1-48 inch pipe).

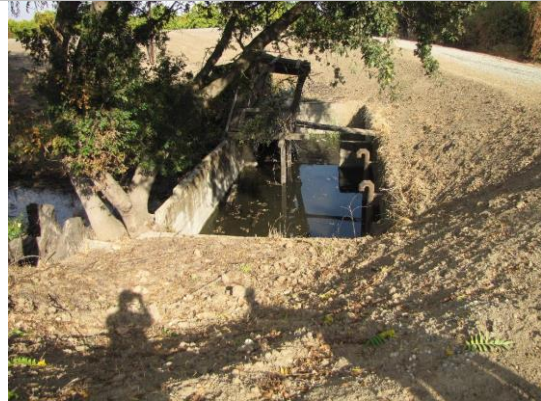
Photo 3 of 3 : UCIP_FA_2015_6623.jpg

UCIP Comments: 4/21/2015 Same as last inspection. Missing positive closure device. Need to determine if structure is still in use--contact owner. If abandoned structure--structure needs to be abandoned. This crossing was listed in the USACE Periodic Inspections as ID# USACE_CESPK_MA1C_2010_p_0393 missing gate. 7/18/2013 Same as last inspection. 12/17/2013 Same as last inspection. 6/23/2014 Same as last inspection.

Abandoned structure (multiple headwalls and pump structure) located near the lower levee (ring levee).

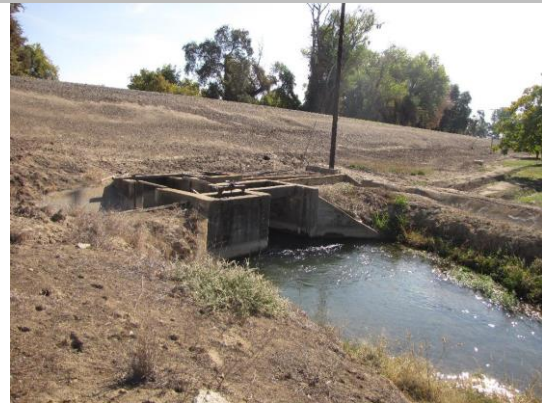
Photo 1 of 3 : UCIP_FA_2015_6821.jpg

Inspector Comments: FS_ID:44669
 DS_ID:17691
 EP_NO: 17471
 FS_HLM: 11.432
 Repair Type: Urgent
 Crossing Status: Found
 UCIP Comments: 4/21/2015 Sink hole still present between risers. Erosion between risers with slide gates located on waterward side; This crossing was listed in the USACE Periodic Inspections as ID# USACE_CESPK_MA1C_2010_p_0398 for possible sinkhole between access gate structures. 7/18/2013 Same as last inspection. 12/17/2013 Same as last inspection. 6/23/2014 Standing water was present in the bottom of the sinkhole.
 FIELD_STRUCT_DESC: 2 of 2: 24 inch diameter HDPE discharge pipes to be connected to the existing standpipe risers within the waterside and parallel to the right (west) bank levee of Sacramento River. (Permit 17471-2002, Maxwell Irrigation District)
 FS Date: 04/22/2015

LM Start	11.19	Rating **	U	Issue No.	670 (cont)
LM End	11.19	Issue Type +	En	Location *	LS

View of concrete distribution box located on landward toe.

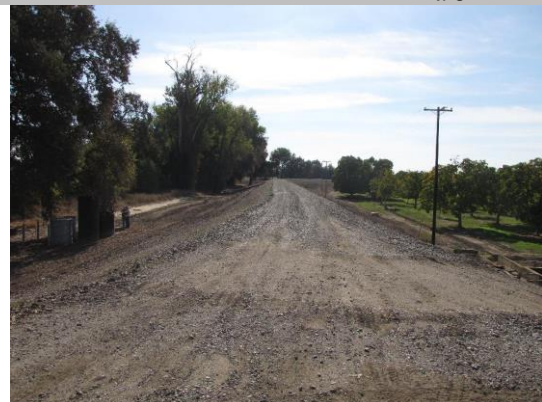
Photo 2 of 3 : UCIP_FA_2015_6822.jpg

Overview of levee crown looking downstream at crossing.

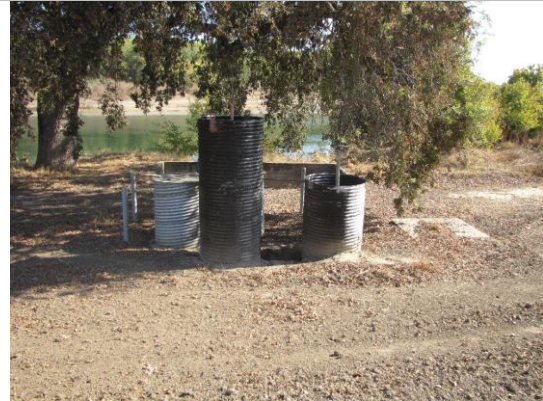
Photo 3 of 3 : UCIP_FA_2015_6823.jpg

LM Start	11.19	Rating **	U	Issue No.	670 (cont)
LM End	11.19	Issue Type +	En	Location *	LS
Category	Supplemental			GPS Latitude/Longitude	
				Start	End
Item	DWR UCIP Field Study			39.343263 °	39.343263 °
				-122.032152 °	-122.032152 °
DWR ID					
Action/Comments					
Inspector Comments: FS_ID:44669					
DS_ID:17691					
EP_NO: 17471					
FS_HLM: 11.432					
Repair Type: Urgent					
Crossing Status: Found

CMP risers located on waterward berm. 18-inch pipe corresponds to downstream riser with slide gate. 24-inch pipe corresponds to upstream riser with slide gate.

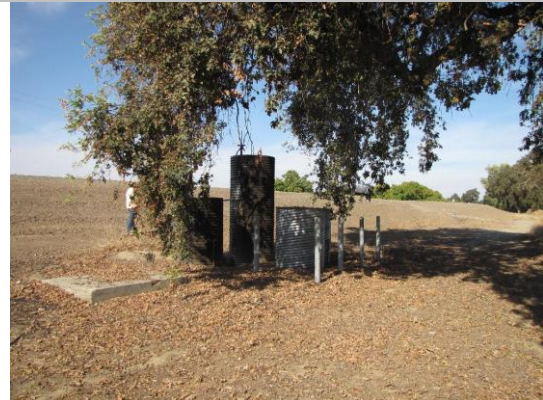
Photo 1 of 3 : UCIP_FA_2015_6818.jpg

LM Start	11.19	Rating **	U	Issue No.	671
LM End	11.19	Issue Type +	En	Location *	LS
Category	Supplemental			GPS Latitude/Longitude	
				Start	End
Item	DWR UCIP Field Study			39.343283 °	39.343283 °
				-122.032145 °	-122.032145 °
DWR ID					
Action/Comments					
Inspector Comments: FS_ID:44668 DS_ID:17624 EP_NO: 17471 FS_HLM: 11.431 Repair Type: Urgent Crossing Status: Found UCIP Comments: 4/21/2015 Sink hole still present between risers.Erosion between risers with slide gates located on waterward side; This crossing was listed in the USACE Periodic Inspections as ID# USACE_CESPK_MA1C_2010_p_0398 for possible sinkhole between access gate structures.7/18/2013 Same as last inspection.12/17/2013 Same as last inspection.6/23/2014 Standing water was present in the bottom of the sinkhole. FIELD_STRUCT_DESC: 1 of 2: 18 inch diameter HDPE discharge pipes to be connected to the existing standpipe risers within the waterside and parallel to the right (west) bank levee of Sacramento River. Pump station is located approximately 450 feet upstream of crossing. (Permit 17471-2002, Maxwell Irrigation District) FS Date: 04/22/2015

View of CMP risers located on waterward berm.

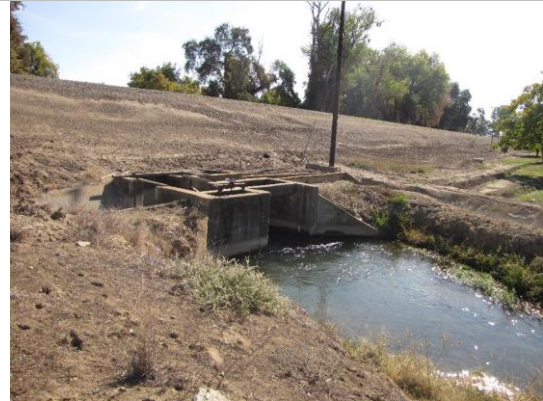
Photo 2 of 3 : UCIP_FA_2015_6819.jpg

Action/Comments					
Inspector Comments: FS_ID:44668 DS_ID:17624 EP_NO: 17471 FS_HLM: 11.431 Repair Type: Urgent Crossing Status: Found UCIP Comments: 4/21/2015 Sink hole still present between risers.Erosion between risers with slide gates located on waterward side; This crossing was listed in the USACE Periodic Inspections as ID# USACE_CESPK_MA1C_2010_p_0398 for possible sinkhole between access gate structures.7/18/2013 Same as last inspection.12/17/2013 Same as last inspection.6/23/2014 Standing water was present in the bottom of the sinkhole. FIELD_STRUCT_DESC: 1 of 2: 18 inch diameter HDPE discharge pipes to be connected to the existing standpipe risers within the waterside and parallel to the right (west) bank levee of Sacramento River. Pump station is located approximately 450 feet upstream of crossing. (Permit 17471-2002, Maxwell Irrigation District) FS Date: 04/22/2015

View of concrete distribution box located on landward toe.

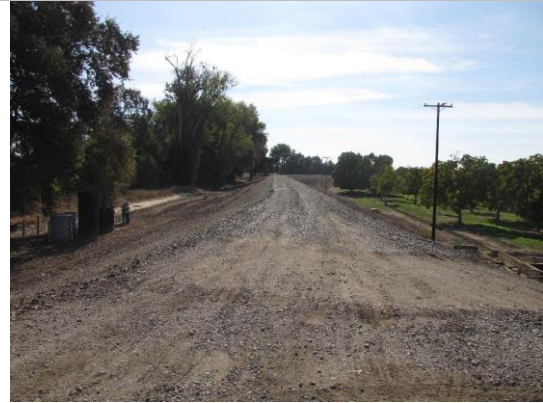
Photo 3 of 3 : UCIP_FA_2015_6820.jpg

Item	DWR UCIP Field Study			39.343283 °	39.343283 °	
				-122.032145 °	-122.032145 °	
DWR ID						
Action/Comments						
Inspector Comments: FS_ID:44668 DS_ID:17624 EP_NO: 17471 FS_HLM: 11.431 Repair Type: Urgent Crossing Status: Found UCIP Comments: 4/21/2015 Sink hole still present between risers.Erosion between risers with slide gates located on waterward side; This crossing was listed in the USACE Periodic Inspections as ID# USACE_CESPK_MA1C_2010_p_0398 for possible sinkhole between access gate structures.7/18/2013 Same as last inspection.12/17/2013 Same as last inspection.6/23/2014 Standing water was present in the bottom of the sinkhole. FIELD_STRUCT_DESC: 1 of 2: 18 inch diameter HDPE discharge pipes to be connected to the existing standpipe risers within the waterside and parallel to the right (west) bank levee of Sacramento River. Pump station is located approximately 450 feet upstream of crossing. (Permit 17471-2002, Maxwell Irrigation District) FS Date: 04/22/2015

Overview of levee crown looking downstream at crossing.

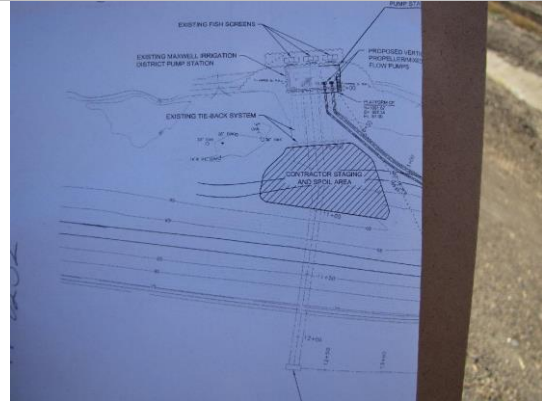
Photo 1 of 3 : UCIP_FA_2015_6142.jpg

Inspector Comments: FS_ID:44686
 DS_ID:20582
 EP_NO: N/A
 FS_HLM: 11.512
 Repair Type: Non-Urgent
 Crossing Status: Found
 UCIP Comments: 4/21/2015 Same as last inspection. Need to determine encroachment permit associated with this crossing. 7/22/2013 Same as last inspection. 12/17/2013 Same as last inspection. 6/23/2014 Same as last inspection.
 FIELD_STRUCT_DESC: 1 of 3: 24 inch discharge pipe through levee. Crossing is tied to existing Maxwell Irrigation District Pump Station located on waterward side. Siphon breaker inside CMP riser located on landward shoulder.
 FS Date: 04/22/2015

LM Start	11.27	Rating **	M	Issue No.	672 (cont)
LM End	11.27	Issue Type +	En	Location *	LS

Drawing of existing Maxwell Irrigation District Conveyance Pipeline
 (DWG available through Permit No. 17471 for work located at LM 11.51).

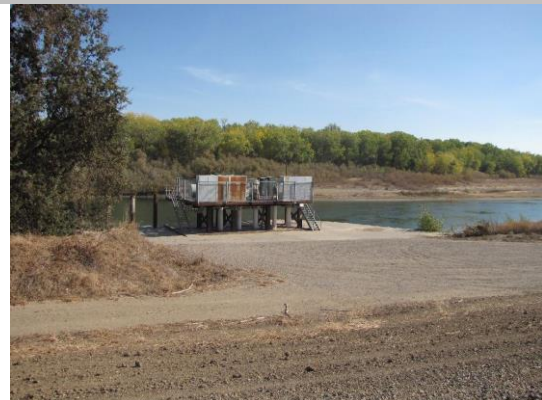
Photo 2 of 3 : UCIP_FA_2015_6143.jpg

Pump station located on waterward side.

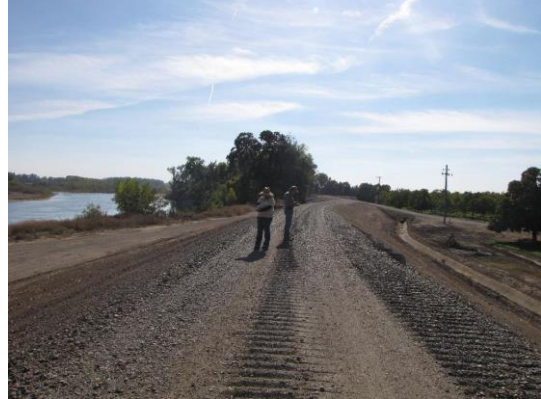
Photo 3 of 3 : UCIP_FA_2015_6144.jpg

LM Start	11.27	Rating **	M	Issue No.	672 (cont)
LM End	11.27	Issue Type +	En	Location *	LS
Category	Supplemental			GPS Latitude/Longitude	
				Start	End
Item	DWR UCIP Field Study			39.344376 °	39.344376 °
				-122.031792 °	-122.031792 °
DWR ID					
Action/Comments					
Inspector Comments: FS_ID:44686 DS_ID:20582 EP_NO: N/A FS_HLM: 11.512 Repair Type: Non-Urgent Crossing Status: Found

Overview of levee crown looking downstream at crossing.

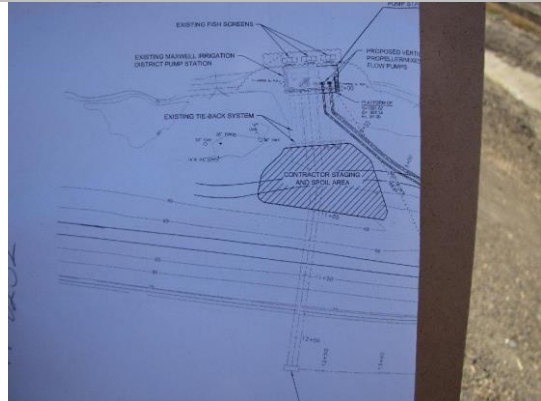
Photo 1 of 3 : UCIP_FA_2015_6145.jpg

LM Start	11.27	Rating **	M	Issue No.	673
LM End	11.27	Issue Type +	En	Location *	LS
Category	Supplemental			GPS Latitude/Longitude	
				Start	End
Item	DWR UCIP Field Study			39.344390 °	39.344390 °
				-122.031787 °	-122.031787 °
DWR ID					
Action/Comments					
Inspector Comments: FS_ID:44687					
DS_ID:20583					
EP_NO: N/A					
FS_HLM: 11.513					
Repair Type: Non-Urgent					
Crossing Status: Found					
UCIP Comments: 4/21/2015 Same as last inspection.Need to determine encroachment permit for this crossing.7/22/2013 Same as last inspection.12/17/2013 Same as last inspection.6/23/2014 Same as last inspection.					
FIELD_STRUCT_DESC: 2 of 3: 24 inch discharge pipe through levee.					
Crossing is tied to existing Maxwell Irrigation District Pump Station located on waterward side. Siphon breaker inside CMP riser located on landward shoulder.					
FS Date: 04/22/2015

Drawing of existing Maxwell Irrigation District Conveyance Pipeline
(DWG available through Permit No. 17471 for work located at LM 11.51).

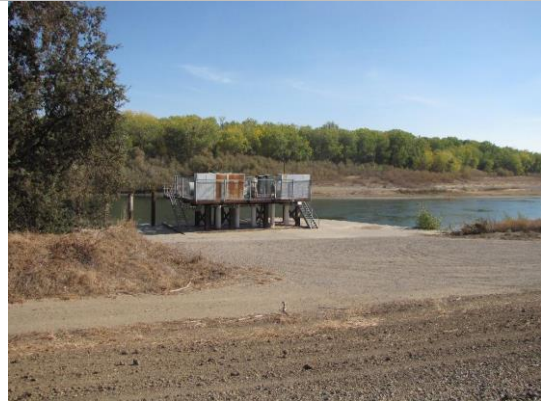
Photo 2 of 3 : UCIP_FA_2015_6146.jpg

Inspector Comments: FS_ID:44687
 DS_ID:20583
 EP_NO: N/A
 FS_HLM: 11.513
 Repair Type: Non-Urgent
 Crossing Status: Found
 UCIP Comments: 4/21/2015 Same as last inspection. Need to determine encroachment permit for this crossing. 7/22/2013 Same as last inspection. 12/17/2013 Same as last inspection. 6/23/2014 Same as last inspection.
 FIELD_STRUCT_DESC: 2 of 3: 24 inch discharge pipe through levee. Crossing is tied to existing Maxwell Irrigation District Pump Station located on waterward side. Siphon breaker inside CMP riser located on landward shoulder.
 FS Date: 04/22/2015

Pump Station located on waterward side.

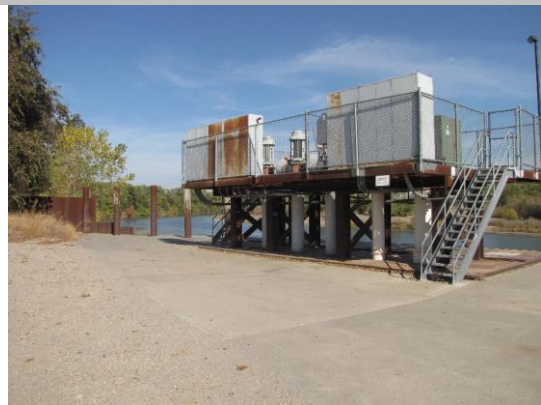
Photo 3 of 3 : UCIP_FA_2015_6147.jpg

Maxwell Irrigation District Pump Station located on waterward side.

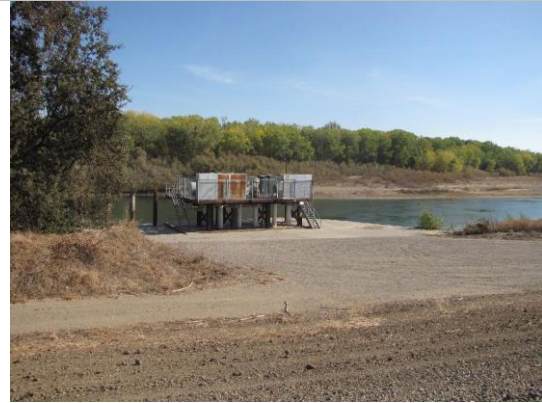
Photo 2 of 3 : UCIP_FA_2015_6149.jpg

LM Start	11.27	Rating **	M	Issue No.	674
LM End	11.27	Issue Type +	En	Location *	LS
Category	Supplemental			GPS Latitude/Longitude	
				Start	End
Item	DWR UCIP Field Study			39.344400 °	39.344400 °
				-122.031785 °	-122.031785 °
DWR ID					
Action/Comments					
Inspector Comments: FS_ID:44689 DS_ID:20584 EP_NO: N/A FS_HLM: 11.514 Repair Type: Non-Urgent Crossing Status: Found

Maxwell Irrigation District Pump Station located on waterward side.

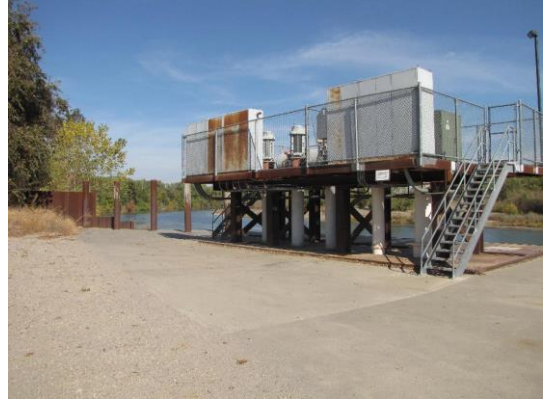
Photo 3 of 3 : UCIP_FA_2015_6305.jpg

LM Start	11.27	Rating **	M	Issue No.	674 (cont)	
LM End	11.27	Issue Type +	En	Location *	LS	
Category	Supplemental			GPS Latitude/Longitude		
				Start	End	
Item	DWR UCIP Field Study			39.344400 °	39.344400 °	
				-122.031785 °	-122.031785 °	
DWR ID						
Action/Comments						
Inspector Comments: FS_ID:44689						
DS_ID:20584						
EP_NO: N/A						
FS_HLM: 11.514						
Repair Type: Non-Urgent						
Crossing Status: Found

Maxwell Irrigation District Pump Station located on waterward side.

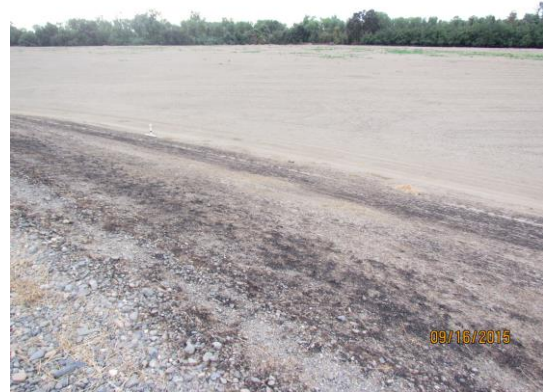
Photo 1 of 1 : FA_2015_MA0001_297_78_20151013_00027.jpg

LM Start	12.27	Rating **	M	Issue No.	78
LM End	12.27	Issue Type +	Ma	Location *	WS
Category	Earthen Levee			GPS Latitude/Longitude	
				Start	End
Item	Animal Control			39.357497 °	39.357497 °
				-122.026093 °	-122.026093 °
DWR ID	DWR_MA0001_01_f_2015_78				
Action/Comments					
Exterminate rodents and backfill and compact or grout burrows.

View of the rodent holes along the waterside slope.

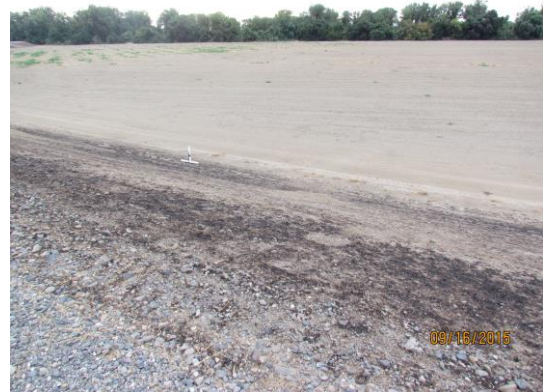
Photo 1 of 1 : FA_2015_MA0001_297_79_20151013_00028.jpg

LM Start	12.49	Rating **	M	Issue No.	79
LM End	12.49	Issue Type +	Ma	Location *	WS
Category	Earthen Levee			GPS Latitude/Longitude	
				Start	End
Item	Animal Control			39.359500 °	39.359500 °
				-122.022980 °	-122.022980 °
DWR ID	DWR_MA0001_01_f_2015_79				
Action/Comments					
No rodents visible, but rodent burrows visible; need to backfill and compact or grout burrows.

View of the rodent holes along the waterside slope.

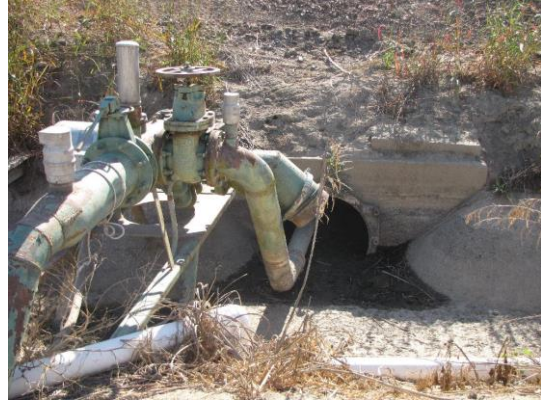
Photo 1 of 3 : UCIP_FA_2015_6306.jpg

LM Start	12.69	Rating **	M	Issue No.	676
LM End	12.69	Issue Type +	En	Location *	WS
Category	Supplemental			GPS Latitude/Longitude	
				Start	End
Item	DWR UCIP Field Study			39.359843 °	39.359843 °
				-122.019529 °	-122.019529 °
DWR ID					
Action/Comments					
Inspector Comments: FS_ID:44694 DS_ID:16445 EP_NO: 9462 FS_HLM: 12.963 Repair Type: Non-Urgent Crossing Status: Found UCIP Comments: 4/21/2015 Same as last inspection. Slide gate unoperable-blocked by sediment. LS-flap gate missing. 5-inch pipe goes through 24-inch crossing--unable to determine is authorized. This crossing was listed in the USACE Periodic Inspections as ID# USACE_CESPK_MA1C_2010_p_0435 for smaller pipe running inside existing crossing.7/22/2013 Same as last inspection.12/17/2013 Same as last inspection.6/23/2014 Same as last inspection. FIELD_STRUCT_DESC: 24-inch corrugated metal pipe through levee. Slide gate on both ends. (ABO No. 9462-1974, Thousand Acre Ranch) FS Date: 04/22/2015

6-inch irrigation pipe through crossing at landward side. Flap gate missing.

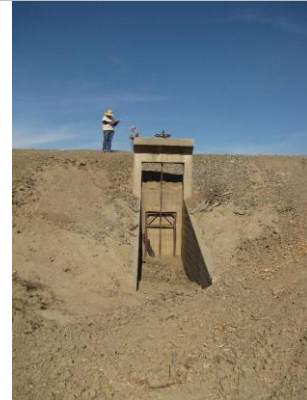
Photo 2 of 3 : UCIP_FA_2015_6307.jpg

WS concrete structure with slide gate. Gate is blocked by sediment.

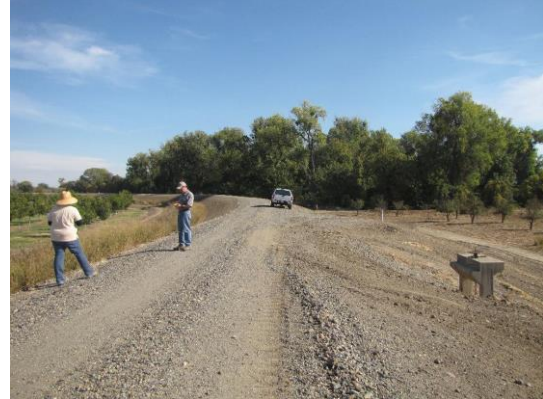
Photo 3 of 3 : UCIP_FA_2015_6308.jpg

LM Start	12.69	Rating **	M	Issue No.	676 (cont)
LM End	12.69	Issue Type +	En	Location *	WS
Category	Supplemental			GPS Latitude/Longitude	
				Start	End
Item	DWR UCIP Field Study			39.359843 °	39.359843 °
				-122.019529 °	-122.019529 °
DWR ID					
Action/Comments					
Inspector Comments: FS_ID:44694					
DS_ID:16445					
EP_NO: 9462					
FS_HLM: 12.963					
Repair Type: Non-Urgent					
Crossing Status: Found

Overview of levee crown looking downstream at crossing.

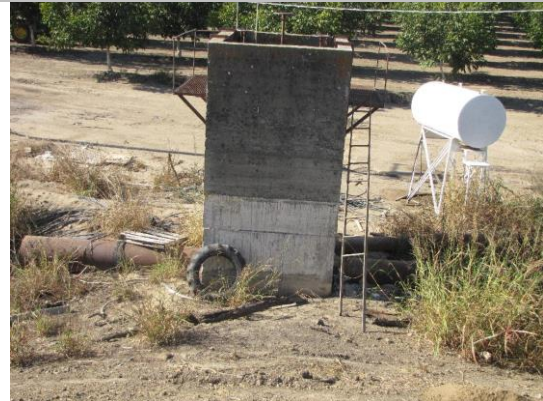
Photo 1 of 3 : UCIP_FA_2015_6364.jpg

LM Start	13.47	Rating **	U	Issue No.	677
LM End	13.47	Issue Type +	En	Location *	WS
Category	Supplemental			GPS Latitude/Longitude	
				Start	End
Item	DWR UCIP Field Study			39.367643 °	39.367643 °
				-122.015212 °	-122.015212 °
DWR ID					
Action/Comments					
Inspector Comments: FS_ID:44700 DS_ID:16443 EP_NO: 9461 FS_HLM: 13.756 Repair Type: Urgent Crossing Status: Found UCIP Comments: 4/21/2015 Same as last inspection.Unable to close positive closure device due to missing ladder-slucce gate inaccessible. Need to determine the condition of the gate. This crossing was listed in the USACE Periodic Inspections as ID# USACE_CESPK_MA1C_2010_p_0453 for an inaccessible gate box with its ladder broken on the waterward side.7/22/2013 Same as last inspection.12/17/2013 Same as last inspection.6/23/2014 Same as last inspection. FIELD_STRUCT_DESC: 36 inch corrugated metal pipe through levee, 21.5 feet below crown. Slide gate in concrete box on waterward end. Pump on the bank. (ABO No. 9461-1974, Annie D. Propfe) This entry matches the Drainage and Irrigation Structure referenced in O&M manual (Station 710+82). FS Date: 04/22/2015

Concrete distribution box located on landward toe.

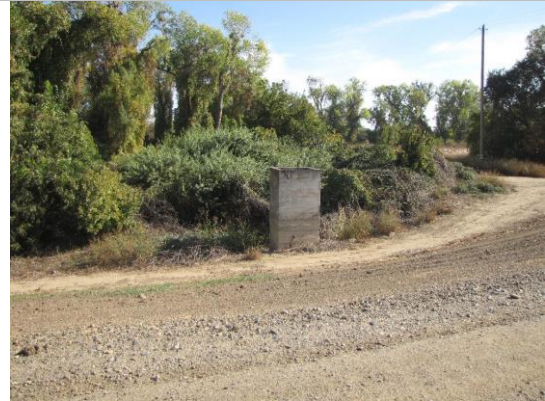
Photo 2 of 3 : UCIP_FA_2015_6365.jpg

Action/Comments					
Inspector Comments: FS_ID:44700 DS_ID:16443 EP_NO: 9461 FS_HLM: 13.756 Repair Type: Urgent Crossing Status: Found UCIP Comments: 4/21/2015 Same as last inspection.Unable to close positive closure device due to missing ladder-slucce gate inaccessible. Need to determine the condition of the gate. This crossing was listed in the USACE Periodic Inspections as ID# USACE_CESPK_MA1C_2010_p_0453 for an inaccessible gate box with its ladder broken on the waterward side.7/22/2013 Same as last inspection.12/17/2013 Same as last inspection.6/23/2014 Same as last inspection. FIELD_STRUCT_DESC: 36 inch corrugated metal pipe through levee, 21.5 feet below crown. Slide gate in concrete box on waterward end. Pump on the bank. (ABO No. 9461-1974, Annie D. Propfe) This entry matches the Drainage and Irrigation Structure referenced in O&M manual (Station 710+82). FS Date: 04/22/2015

View of waterward side at crossing.

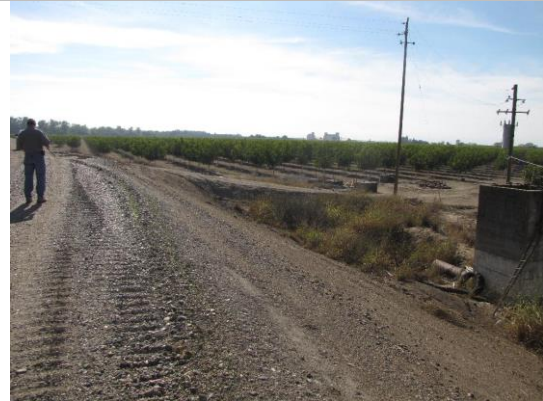
Photo 3 of 3 : UCIP_FA_2015_6366.jpg

Item	DWR UCIP Field Study			39.367643 °	39.367643 °	
				-122.015212 °	-122.015212 °	
DWR ID						
Action/Comments						
Inspector Comments: FS_ID:44700 DS_ID:16443 EP_NO: 9461 FS_HLM: 13.756 Repair Type: Urgent Crossing Status: Found UCIP Comments: 4/21/2015 Same as last inspection.Unable to close positive closure device due to missing ladder-slucce gate inaccessible. Need to determine the condition of the gate. This crossing was listed in the USACE Periodic Inspections as ID# USACE_CESPK_MA1C_2010_p_0453 for an inaccessible gate box with its ladder broken on the waterward side.7/22/2013 Same as last inspection.12/17/2013 Same as last inspection.6/23/2014 Same as last inspection. FIELD_STRUCT_DESC: 36 inch corrugated metal pipe through levee, 21.5 feet below crown. Slide gate in concrete box on waterward end. Pump on the bank. (ABO No. 9461-1974, Annie D. Propfe) This entry matches the Drainage and Irrigation Structure referenced in O&M manual (Station 710+82). FS Date: 04/22/2015

View of landward side looking downstream at crossing.

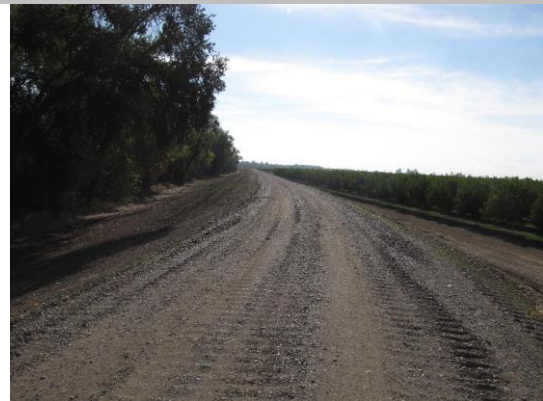
Photo 1 of 2 : UCIP_FA_2015_6367.jpg

LM Start	13.78	Rating **	M	Issue No.	678
LM End	13.78	Issue Type +	En	Location *	WS
Category	Supplemental			GPS Latitude/Longitude	
				Start	End
Item	DWR UCIP Field Study			39.371934 °	39.371934 °
				-122.012945 °	-122.012945 °
DWR ID					
Action/Comments					
Inspector Comments: FS_ID:44709 DS_ID:16442 EP_NO: N/A FS_HLM: 14.083 Repair Type: Non-Urgent Crossing Status: Found UCIP Comments: 4/21/2015 Slide gate is still buried.Slide gate is buried-non-fuctional. This crossing was listed in the USACE Periodic Inspections as ID# USACE_CESPK_MA1C_2010_p_0457 for buried slide gate.7/22/2013 Same as last inspection.12/17/2013 Same as last inspection.6/23/2014 Same as last inspection. FIELD_STRUCT_DESC: Abandoned 36-inch corrugated metal pipe through levee. Slide gate on waterward end. (Davis Ranches) FS Date: 04/22/2015

Overview of levee crown looking downstream at crossing.

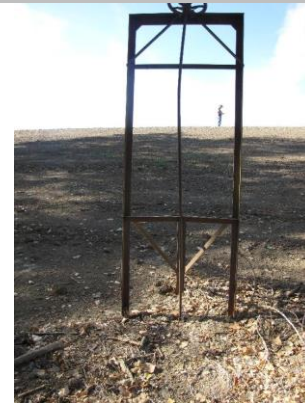
Photo 2 of 2 : UCIP_FA_2015_6368.jpg

LM Start	13.78	Rating **	M	Issue No.	678 (cont)	
LM End	13.78	Issue Type +	En	Location *	WS	
Category	Supplemental			GPS Latitude/Longitude		
				Start	End	
Item	DWR UCIP Field Study			39.371934 °	39.371934 °	
				-122.012945 °	-122.012945 °	
DWR ID						
Action/Comments						
Inspector Comments: FS_ID:44709 DS_ID:16442 EP_NO: N/A FS_HLM: 14.083 Repair Type: Non-Urgent Crossing Status: Found UCIP Comments: 4/21/2015 Slide gate is still buried.Slide gate is buried-non-fuctional. This crossing was listed in the USACE Periodic Inspections as ID# USACE_CESPK_MA1C_2010_p_0457 for buried slide gate.7/22/2013 Same as last inspection.12/17/2013 Same as last inspection.6/23/2014 Same as last inspection. FIELD_STRUCT_DESC: Abandoned 36-inch corrugated metal pipe through levee. Slide gate on waterward end. (Davis Ranches) FS Date: 04/22/2015

Slide gate buried-non-functional.

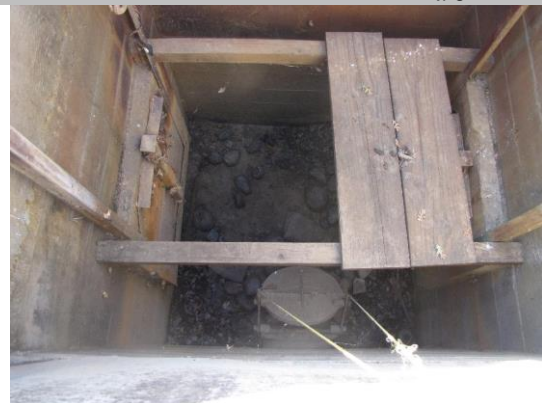
Photo 1 of 3 : UCIP_FA_2015_6369.jpg

LM Start	14.28	Rating **	M	Issue No.	679
LM End	14.28	Issue Type +	En	Location *	WS
Category	Supplemental			GPS Latitude/Longitude	
				Start	End
Item	DWR UCIP Field Study			39.378568 °	39.378568 °
				-122.013262 °	-122.013262 °
DWR ID					
Action/Comments					
Inspector Comments: FS_ID:44714 DS_ID:16441 EP_NO: 9460 FS_HLM: 14.59 Repair Type: Non-Urgent Crossing Status: Found UCIP Comments: 4/21/2015 Same as last inspection.Need to determine if crossing is still being used there are some abandoned features that remain at this crossing--crossing has been modified. This crossing was listed in the USACE Periodic Inspections as ID# USACE_CESPK_MA1C_2010_p_0464 for abandoned pump station.7/22/2013 Same as last inspection.12/17/2013 Same as last inspection.6/23/2014 Same as last inspection. FIELD_STRUCT_DESC: 18-inch steel pipe through levee. Gate valve on the waterward end. Pump house on the waterward berm. Concrete distribution box and flap gate at the landward toe. (ABO No. 9460-1974, Morici Corporation) FS Date: 04/22/2015

Inside view of concrete distribution box located on landward toe.

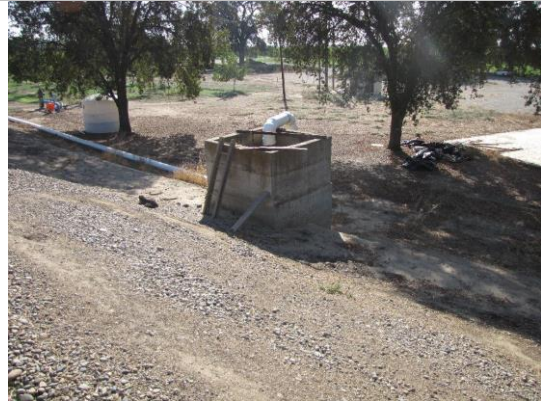
Photo 2 of 3 : UCIP_FA_2015_6370.jpg

Action/Comments					
Inspector Comments: FS_ID:44714 DS_ID:16441 EP_NO: 9460 FS_HLM: 14.59 Repair Type: Non-Urgent Crossing Status: Found UCIP Comments: 4/21/2015 Same as last inspection. Need to determine if crossing is still being used there are some abandoned features that remain at this crossing--crossing has been modified. This crossing was listed in the USACE Periodic Inspections as ID# USACE_CESPK_MA1C_2010_p_0464 for abandoned pump station. 7/22/2013 Same as last inspection. 12/17/2013 Same as last inspection. 6/23/2014 Same as last inspection. FIELD_STRUCT_DESC: 18-inch steel pipe through levee. Gate valve on the waterward end. Pump house on the waterward berm. Concrete distribution box and flap gate at the landward toe. (ABO No. 9460-1974, Morici Corporation) FS Date: 04/22/2015

Concrete distribution box located on landward toe.

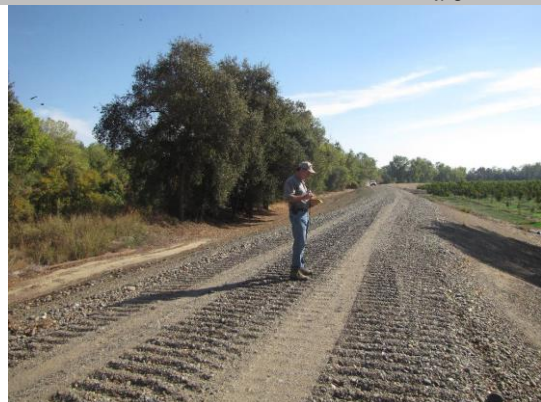
Photo 3 of 3 : UCIP_FA_2015_6504.jpg

View of levee crown looking downstream at crossing.

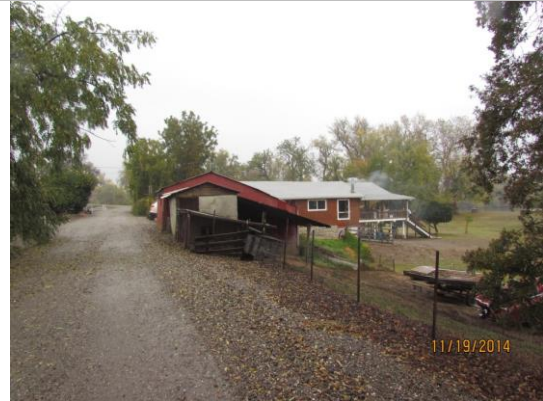
Photo 1 of 1 : FA_2015_MA0001_297_14_20150910_00007.jpg

LM Start	16.08	Rating **	U	Issue No.	14
LM End	16.08	Issue Type +	En	Location *	WS
Category	Earthen Levee			GPS Latitude/Longitude	
				Start	End
Item	Encroachments			39.403930 °	39.403930 °
				-122.008925 °	-122.008925 °
DWR ID	DWR_MA0001_01_s_2012_14				
Action/Comments					
Building

View of the building on the waterside slope.

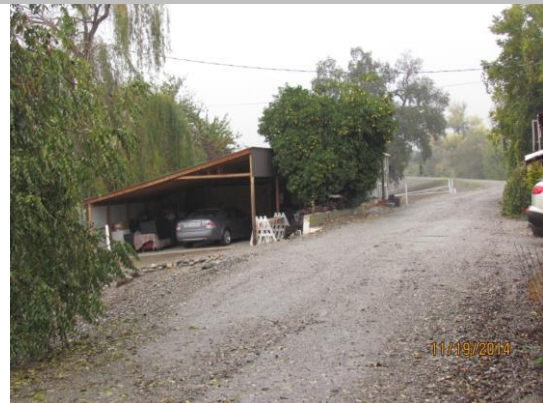
Photo 1 of 1 : FA_2015_MA0001_297_26_20150910_00011.jpg

LM Start	16.10	Rating **	U	Issue No.	26
LM End	16.10	Issue Type +	En	Location *	LS
Category	Earthen Levee			GPS Latitude/Longitude	
				Start	End
Item	Encroachments			39.404135 °	39.404135 °
				-122.008797 °	-122.008797 °
DWR ID	DWR_MA0001_01_s_2012_26				
Action/Comments					
Building

View of the building on the landside slope.

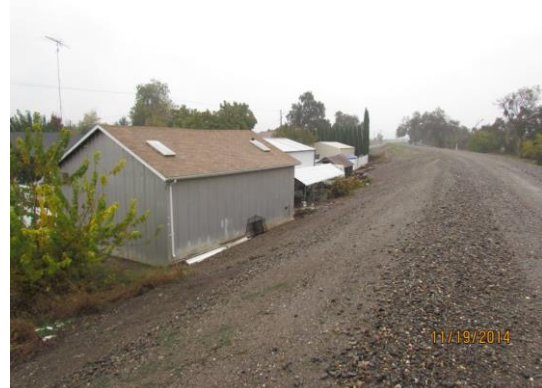
Photo 1 of 1 : FA_2015_MA0001_297_46_20150910_00013.jpg

LM Start	16.31	Rating **	U	Issue No.	46
LM End	16.33	Issue Type +	En	Location *	LS
Category	Earthen Levee			GPS Latitude/Longitude	
				Start	End
Item	Encroachments			39.407225 °	39.407545 °
				-122.008570 °	-122.008640 °
DWR ID	DWR_MA0001_01_s_2012_46				
Action/Comments					
Building

View of the building along the landside toe.

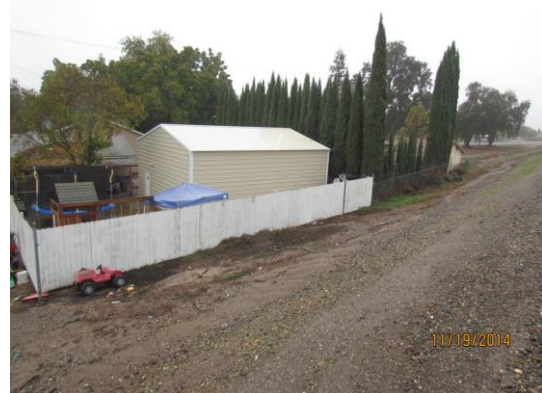
Photo 1 of 1 : FA_2015_MA0001_297_47_20150910_00014.jpg

LM Start	16.34	Rating **	U	Issue No.	47
LM End	16.35	Issue Type +	En	Location *	LS
Category	Earthen Levee			GPS Latitude/Longitude	
				Start	End
Item	Encroachments			39.407670 °	39.407823 °
				-122.008685 °	-122.008740 °
DWR ID	DWR_MA0001_01_s_2012_47				
Action/Comments					
Fence

View of the fence along the landside toe.

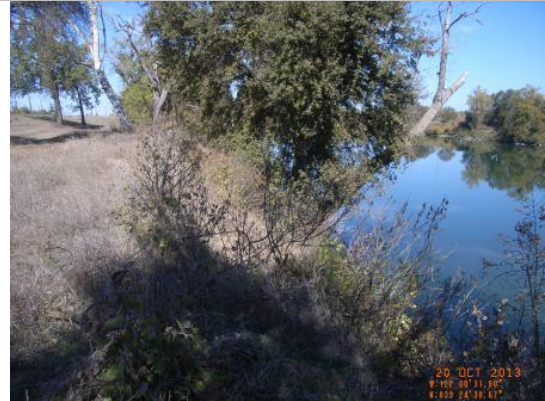
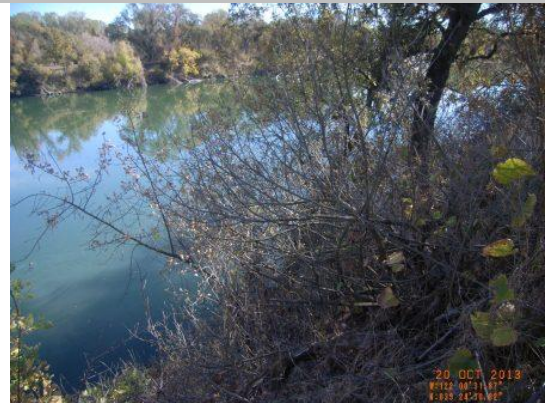
Photo 1 of 2 : USACE2013A_SAC_164-3_R_1.jpg

LM Start	16.35	Rating **	M	Issue No.	9
LM End	16.58	Issue Type +	Ma	Location *	WS
Category	Supplemental			GPS Latitude/Longitude	
				Start	End
Item	2015 USACE Erosion Survey, DRAFT			39.407837 °	39.411111 °
				-122.008763 °	-122.009238 °
DWR ID					
Action/Comments					
Inspector Comments: Erosion site added in 1997 and removed in 2005. 2009 - Site added back in, hard toe with slow moving erosion. Potential geotechnical failure. 2011 - Site extended downstream. 2015: Last observed in 2013. [2015 Site ID: SAC_164-3_R]
